TECHNICAL MEMORANDUM 1330

## DESCRIPTION OF LAW SYSTEM AND CONTROL OF EROSION IN ROCKET MOTOR

JANUARY 1964

PICATINNY ARSENAL DOVER, NEW JERSEY

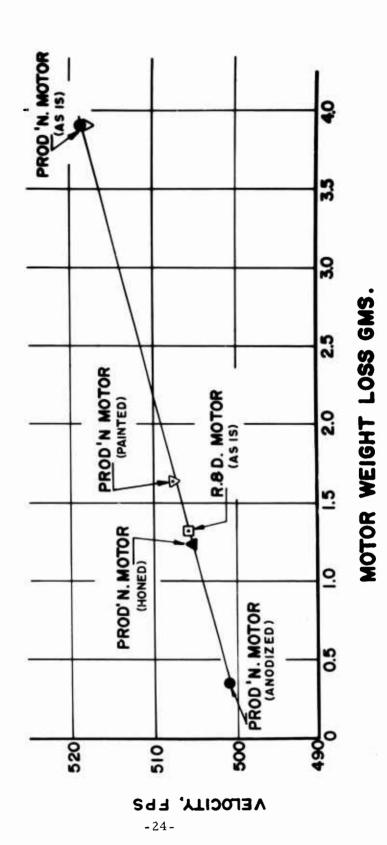
The interacting effects of weight loss, velocity, and flame leakage can be seen graphically in Figure 15. Velocity and weight loss at 140°F appear to correlate very well. It is noted that the honed production motors, the painted motors and the R&D motors are very close together, while the anodized motors, which suffer the least weight loss, also produce a downward velocity bias. The production motors, which had an average weight loss of 3.85 grams, had a velocity approximately 17 fps higher than the anodized motors. Thus, it is concluded that if the motor weight loss is kept below 1.75 grams, flame leakage will be eliminated and no velocity bias will occur.

VELOCITY VS MOTOR WEIGHT LOSS LAW MOTOR 140°F FIRING
